Beryllium legacy issues at AWE Aldermaston - Plant and Equipment

**Clive Le Gresley
Be Plant Manager**

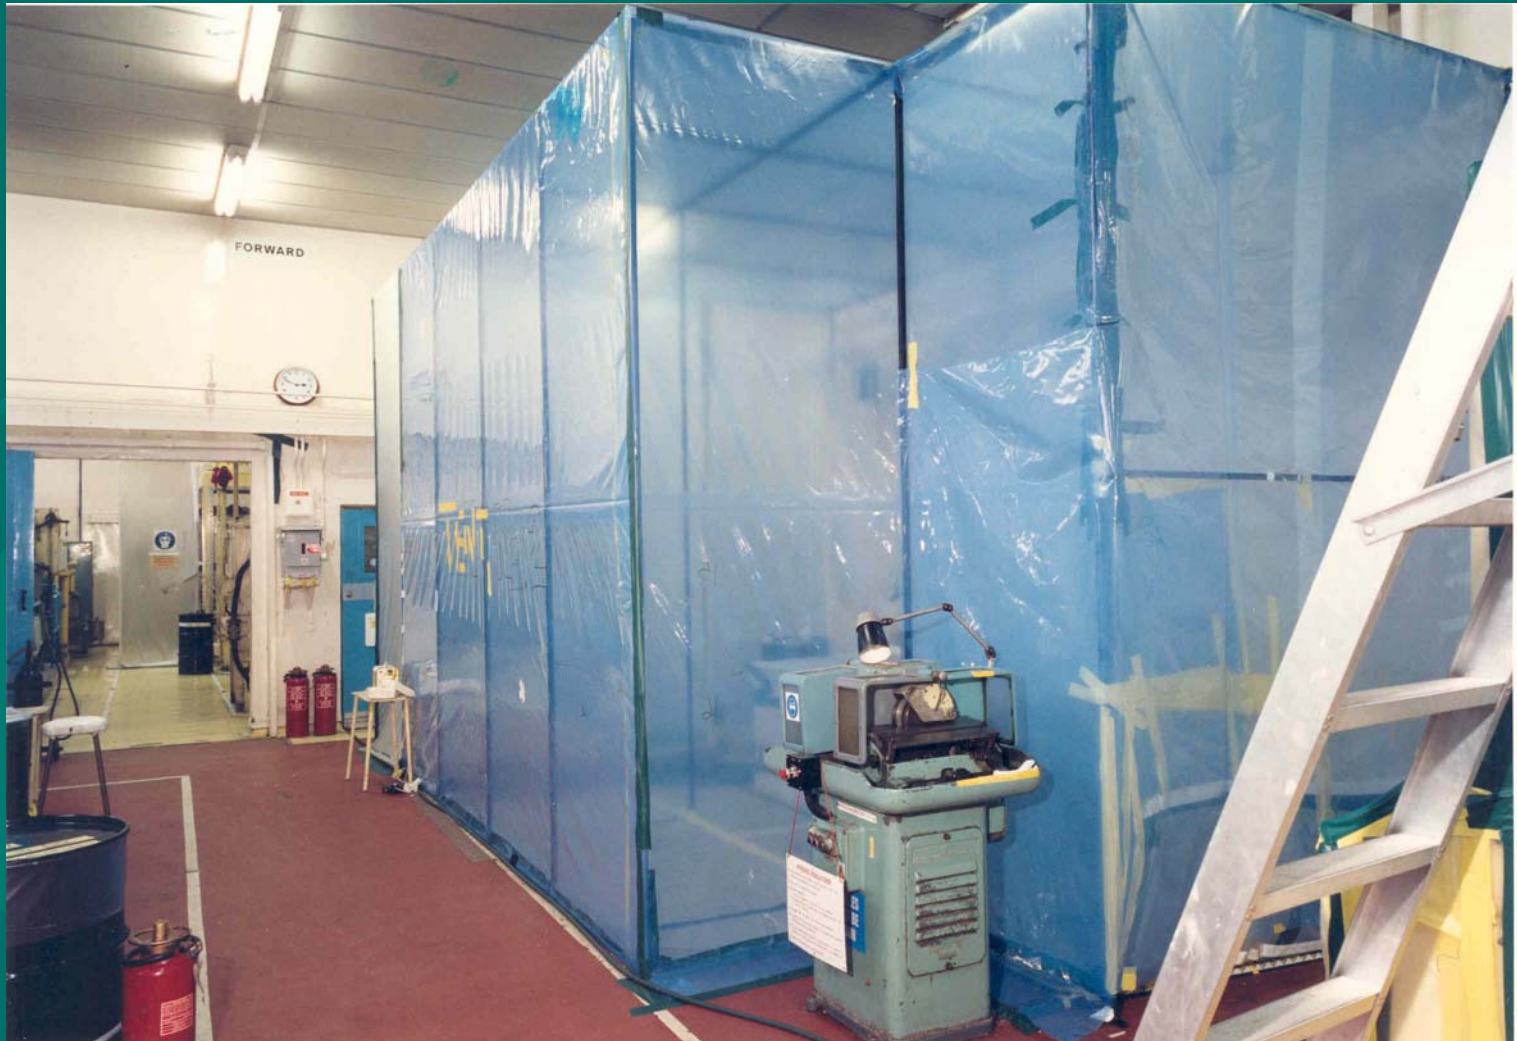
EXAMPLE

- Built from Dexion/Speediframe.
- Covered with PVC, taped seams.
- Connected to building HVAC to provide depression for particulate containment. If this doesn't work, use a portable air-mover (HEPA filtered exhaust).
- Double cell entry/exit airlock chamber built onto tent.
- Clear vision panels provided.
- Certified by HVAC specialists to confirm appropriate construction and airflows through airlock.

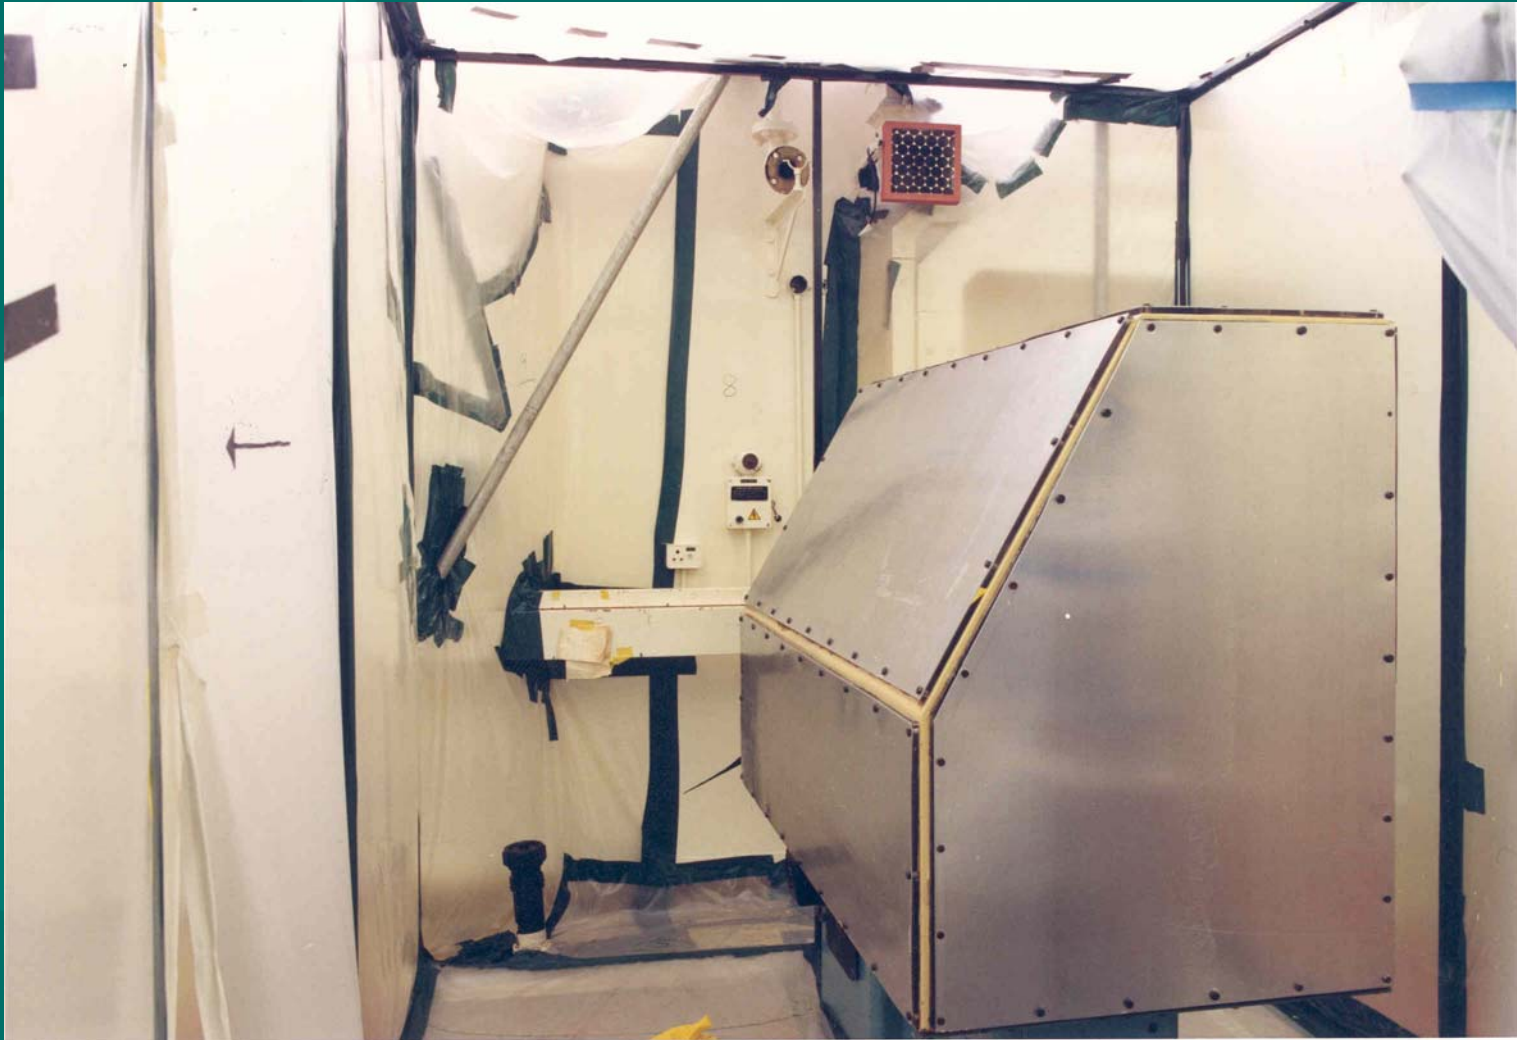
PACKAGE (1)

- Consider RPE zone requirements
- Remove obvious waste – paper, gloves.
- Remove hand tools, “sharps” and chemicals.
- Collect Be swarf (for recycling - possibly).
- “Coarse clean” eg soak up machine tool oil.
- Disconnect from services.
- Backfill with soft waste – coveralls etc.
- Double wrap in PVC.
- Dispose.
